## CARTER SERVICE BULLETIN

### GTR STEERING IMPROVEMENT

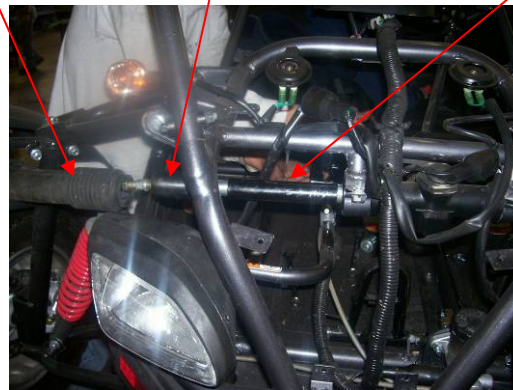
On some of our GTR units the steering is not sufficient. The steering system turns more to the right than to the left. In order to fix this situation, we must shorten the steering stop tubing by ½” and set the steering system correctly.

Rubber boot                      Ball joint end                      Steering Stop Tubing

1. Shorten the steering stop.
  - a. Remove the passenger side rubber boot, ball joint end, and steering stop tubing.
  - b. Cut off ½” on one end of the steering stop tubing and reassemble.

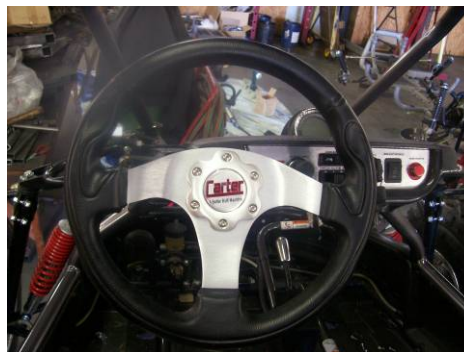
2. Setting the steering system.
  - a. The steering wheel must be set upright when the rack and pinion is centered.
  - b. The rack and pinion is centered when it has the same amount of travel to both the right and left side.
  - c. In order to check this:
    - a. Center the steering wheel.

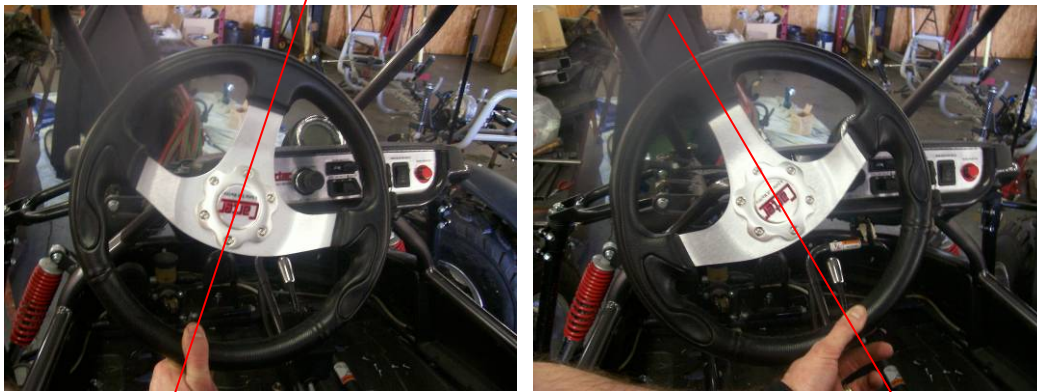
- b. Turn the wheel to the left and to the right.

- c. The steering wheel must lock in both directions the same position as shown.
- d. If the steering wheel does not lock the same as the picture above you must remove the steering wheel from the steering U-joint, rotate the wheel the appropriate direction and then reinsert the steering wheel into the steering U-joint.
- d. Now you must set the tires to point straight and parallel with each other.

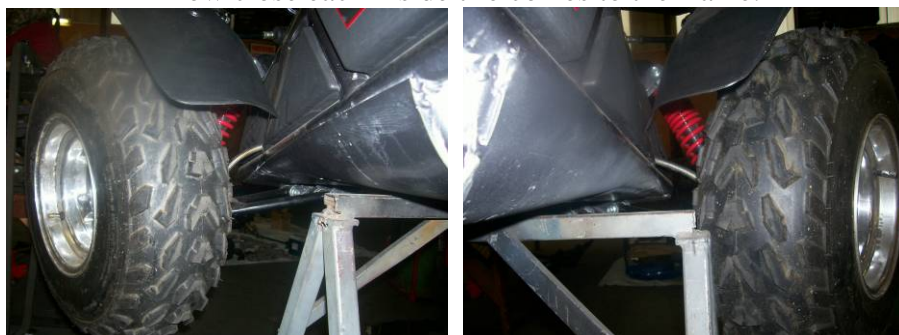
- e. Now you must check to see if each tire turns the same
  - a. Do this by turning the tires to the left and to the right and checking how close each inside tire comes to the frame.
