CARTER SERVICE BULLETIN

GTR STEERING IMPROVEMENT

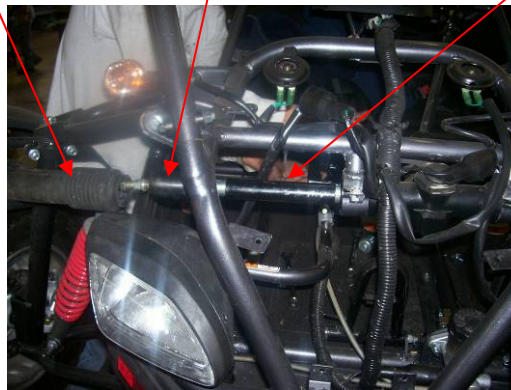
On some of our GTR units the steering is not sufficient. The steering system turns more to the right than to the left. In order to fix this situation, we must shorten the steering stop tubing by ½” and set the steering system correctly.

Rubber boot Ball joint end Steering Stop Tubing

1. Shorten the steering stop.
 - a. Remove the passenger side rubber boot, ball joint end, and steering stop tubing.
 - b. Cut off ½” on one end of the steering stop tubing and reassemble.

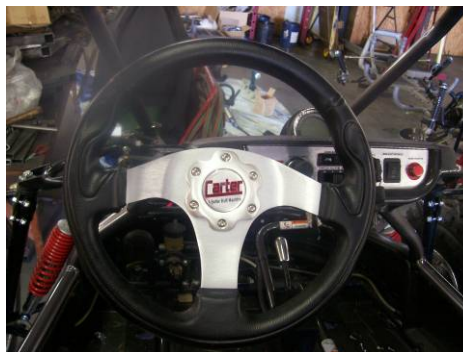
2. Setting the steering system.
 - a. The steering wheel must be set upright when the rack and pinion is centered.
 - b. The rack and pinion is centered when it has the same amount of travel to both the right and left side.
 - c. In order to check this:
 - a. Center the steering wheel.

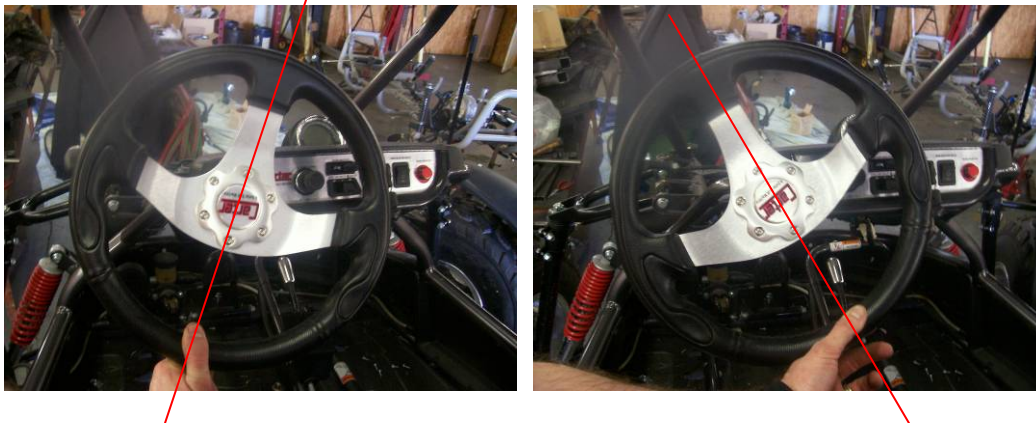
- b. Turn the wheel to the left and to the right.

- c. The steering wheel must lock in both directions the same position as shown.
- d. If the steering wheel does not lock the same as the picture above you must remove the steering wheel from the steering U-joint, rotate the wheel the appropriate direction and then reinsert the steering wheel into the steering U-joint.
- d. Now you must set the tires to point straight and parallel with each other.
