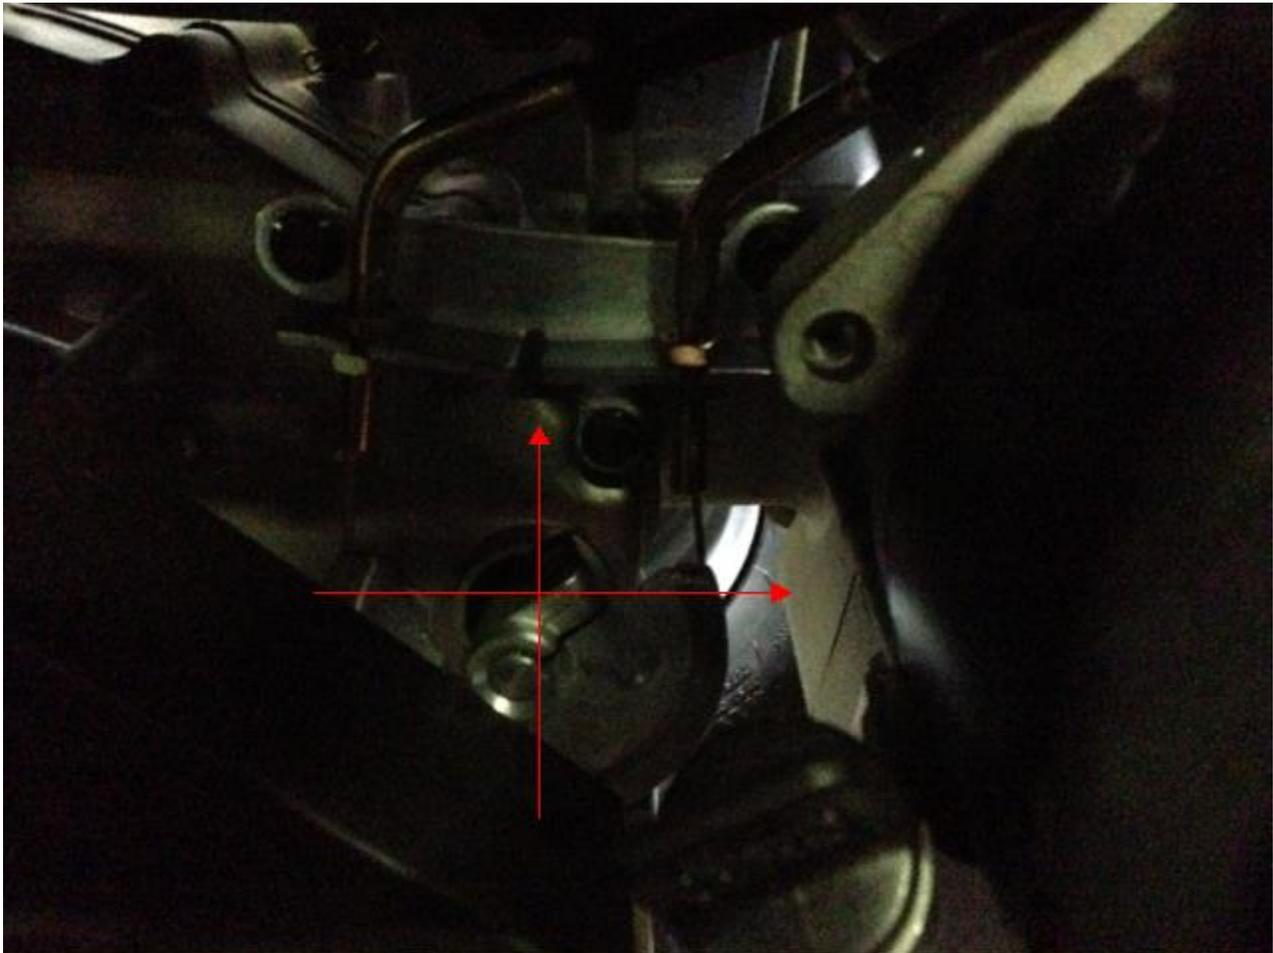
(by neutral "N" shifting)

- 1, loose the reverse cable adjustment bolt on the cable fixed bracket (40001-300GK)
- 2, turn the shifter disk (40002-300GK) a little bit until the engine is not engaged at neutral "N"
- 3, put the shifting handle bar to the "N" position of the shifter hoise assy. (40700-300GK)
- 4, fix the reverse cable adjustment bolt, be sure that both ends of the shifter disk is horizontal, like indicated in the picture 1, and the picture 2 and 3 is showing you how the shifter disk looks like by "F" and "R" shifting.

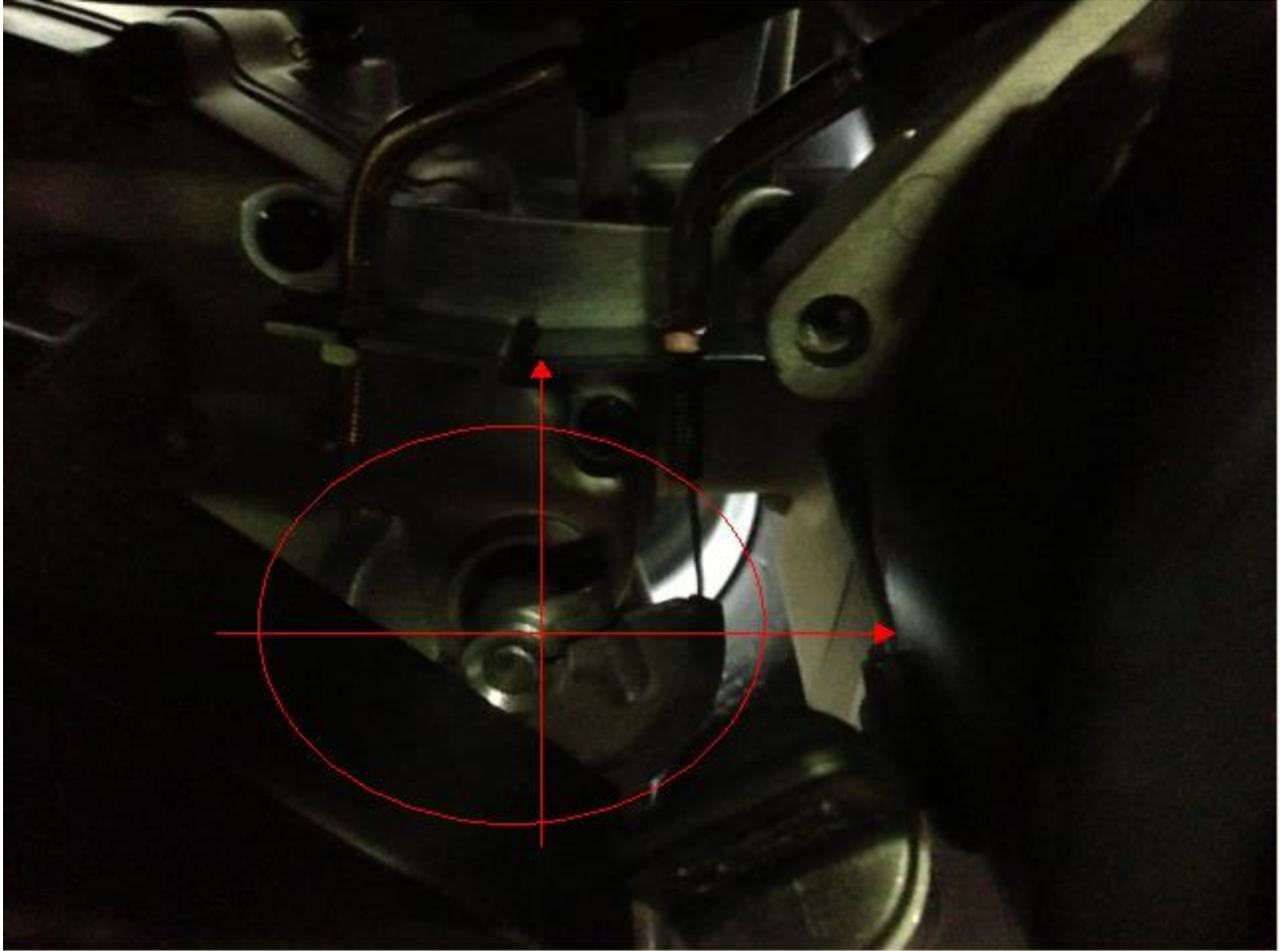
(By forward "F" shifting)

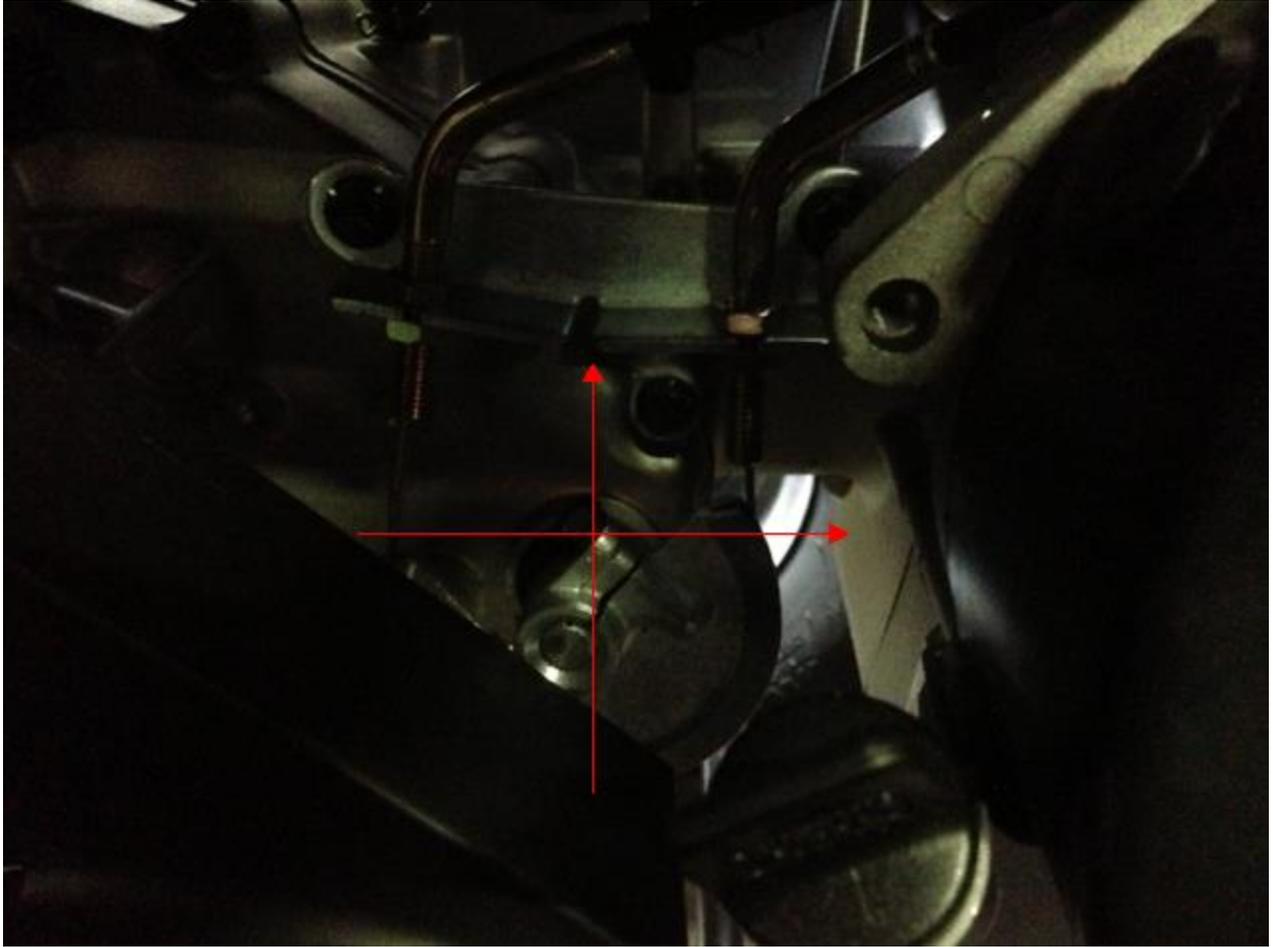
(by reverse "R" shifting)
